UNDERWATER BRIDGE INSPECTION REPORT

STRUCTURE NO. 7221

VERMILLION RIVER

MINNESOTA DEPARTMENT OF TRANSPORTATION
UNDERWATER BRIDGE INSPECTION

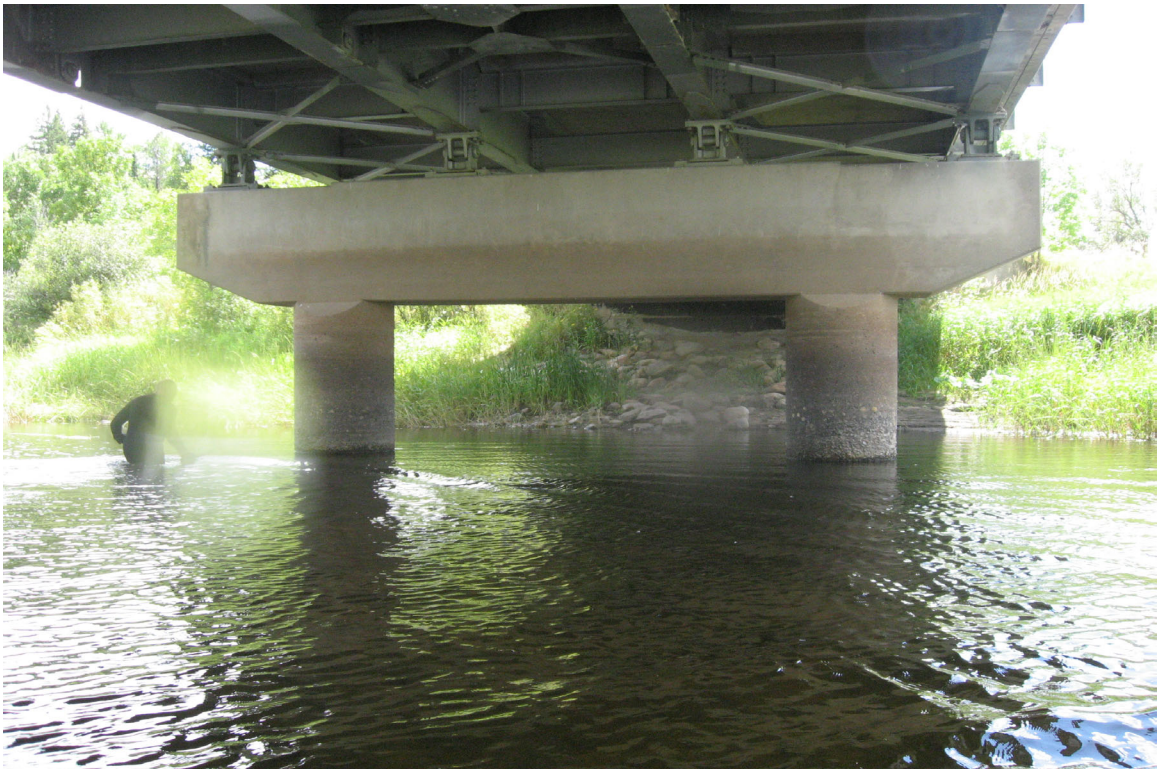
Photograph 2. Overall of Pier 1, Looking Southeast.

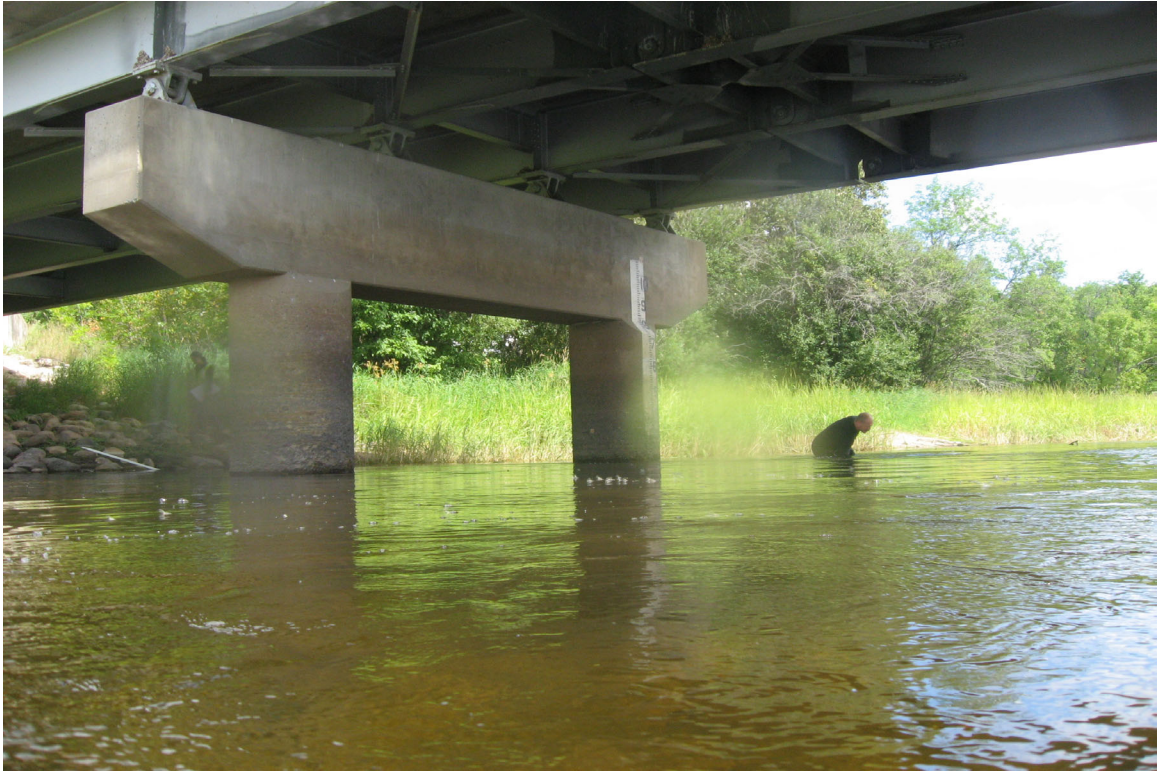
Photograph 3. View of Pier 2, Looking Northeast.

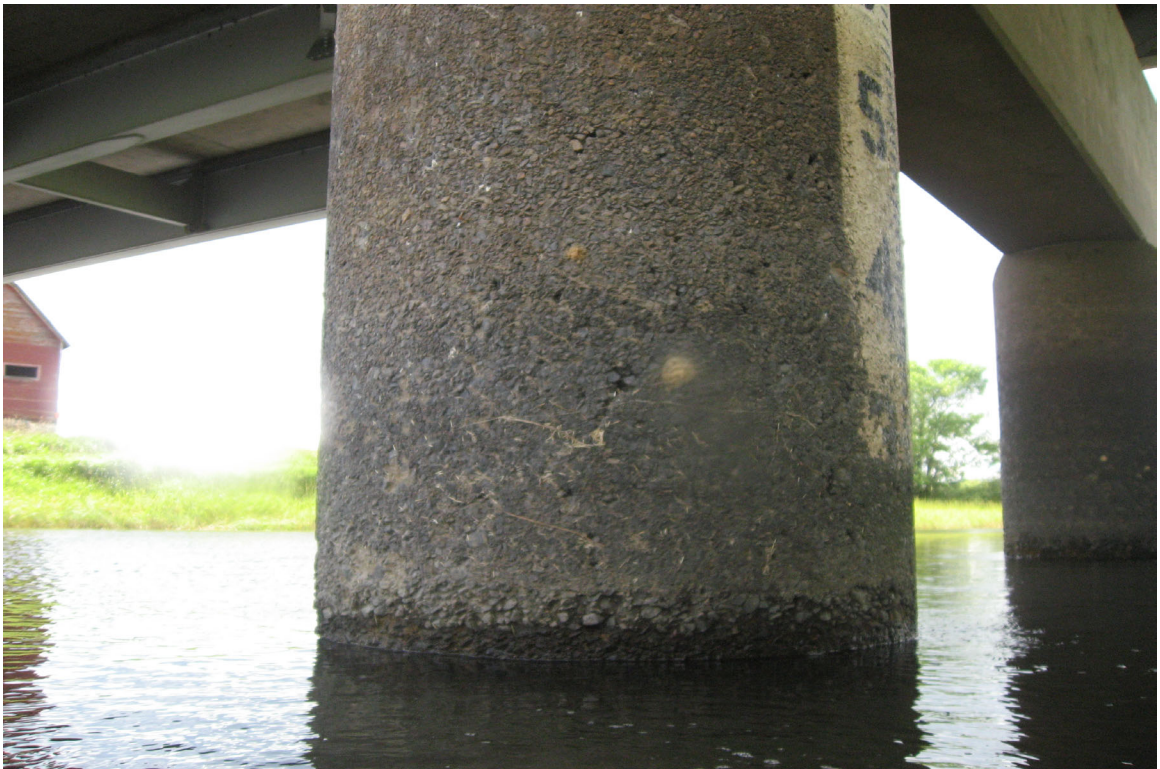
- (A) Scaling was observed from 4 feet above the waterline to 1 foot below the waterline with ½ inch maximum penetration at the upstream and downstream columns of Piers 1 and 2.
- (B) Scour depressions 6 feet in radius by a maximum depth of 2 feet were observed at the upstream and downstream columns of both piers.
- (C) A light accumulation of timber debris consisting of logs up to 10 inch in diameter was located at the upstream column of Pier 2 at the channel bottom.
- (D) A moderate accumulation of timber debris consisting of 1 foot diameter and smaller logs and branches was observed at the upstream column of Pier 1 extending from the channel bottom up 2 feet.

Photograph 4. View of Typical Scaling at Upstream Column of Pier 2, Looking Southwest.

- (A) Reinspect the submerged substructure units at the normal maximum recommended (NBIS) interval of five (5) years.

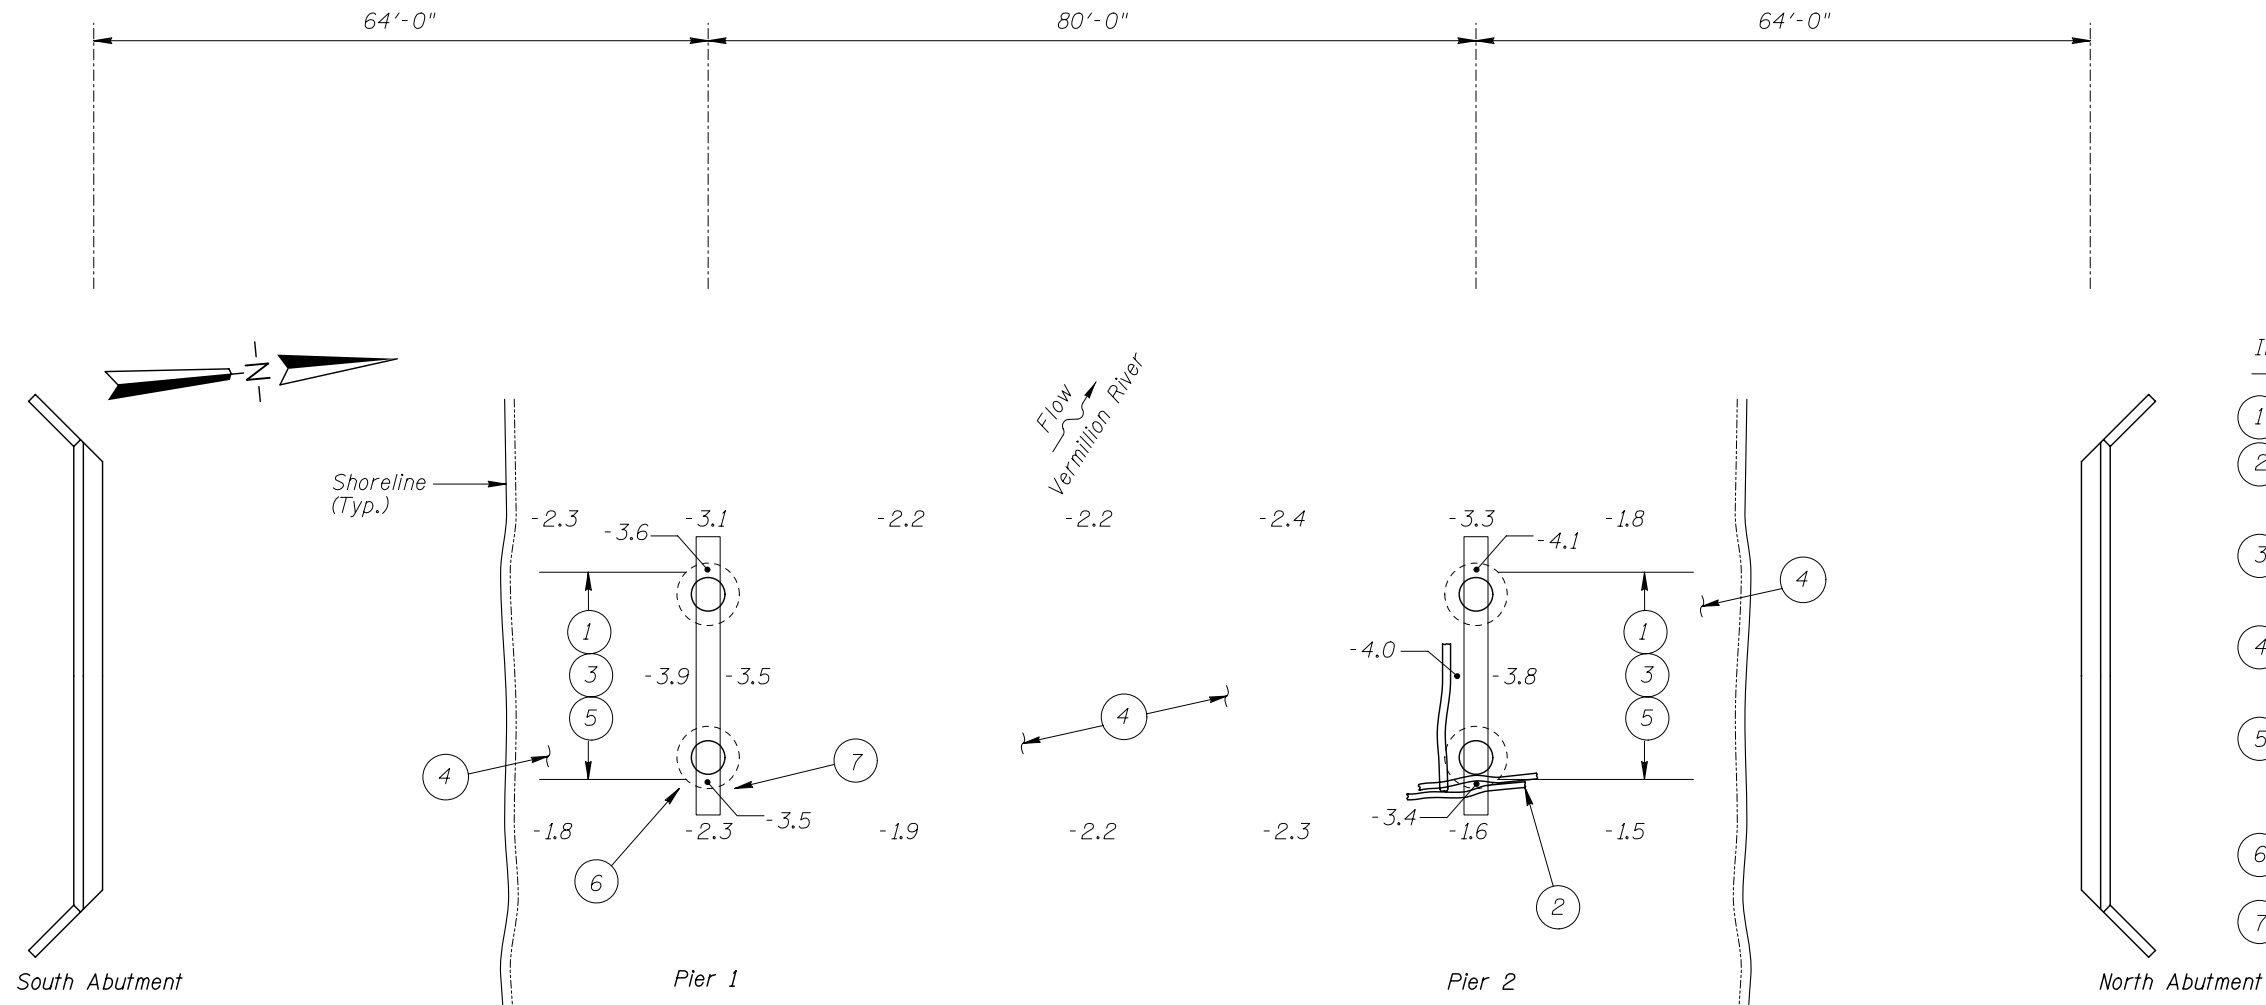
INSPECTION AND SOUNDING PLAN

The substructure units inspected at Bridge No. 7221, Piers 1 and 2, were found to be generally in good condition. The few defects and areas of soft concrete that were observed are not structurally significant at this time. Scour depressions, 6 feet in radius with 2 feet of depth maximum, were observed at the upstream and downstream columns of Piers 1 and 2. Otherwise, the channel bottom at the bridge appeared stable.
